Manhole Inspection Summary

Manhole # S21AA2014MH

Insp Date: **11/21/06 2:58 PM**

Location Address: **MATTFELDT AVE**

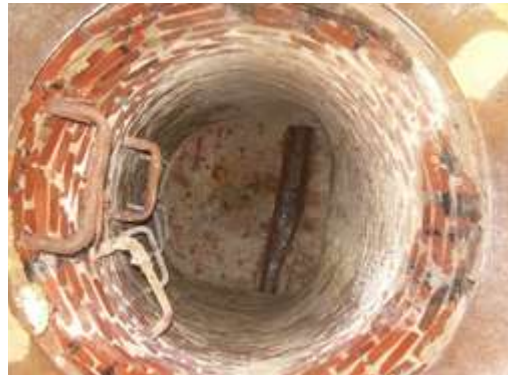
Top View

Corroded steps. Bench debris.

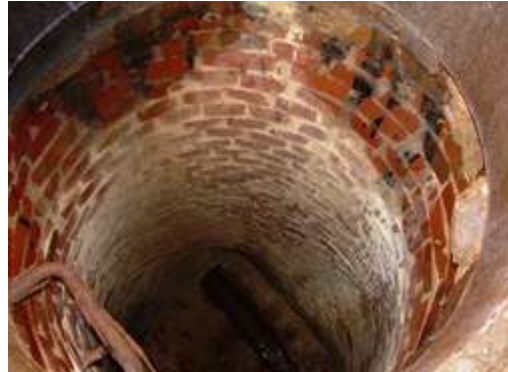
Defect

Frame leaks. Adjustment deterioration.
Adjustment, Corbel, and Barrel infiltration.

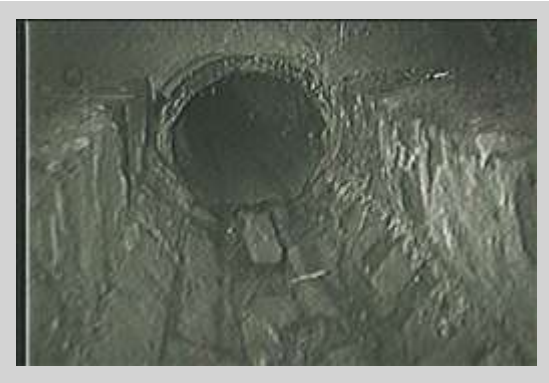
8 in. Circular Gravity Sewer Pipe Out @ 12 O'Clock

Comments **The O12 pipe picture shows Channel deterioration.**

Deposits: ☐ None ☐ Mud ☐ Sludge ☐ Debris ☒ Grease

Silt Depth: **0** (in.) Deposits Extent: **Light**

Infiltration: **Evidence** Pipe Seal Cond: **Cracked**

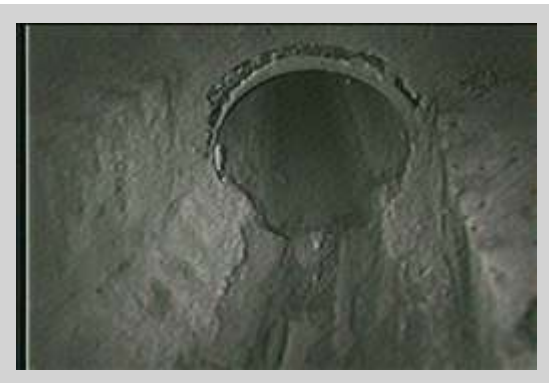
8 in. Circular Gravity Sewer Pipe In @ 7 O'Clock

Infiltration: **Evidence** Pipe Seal Cond: **Unknown**
